Technical Report HL-96-22
December 1996

Demonstration Erosion Control Project Monitoring Program

Fiscal Year 1994 Report

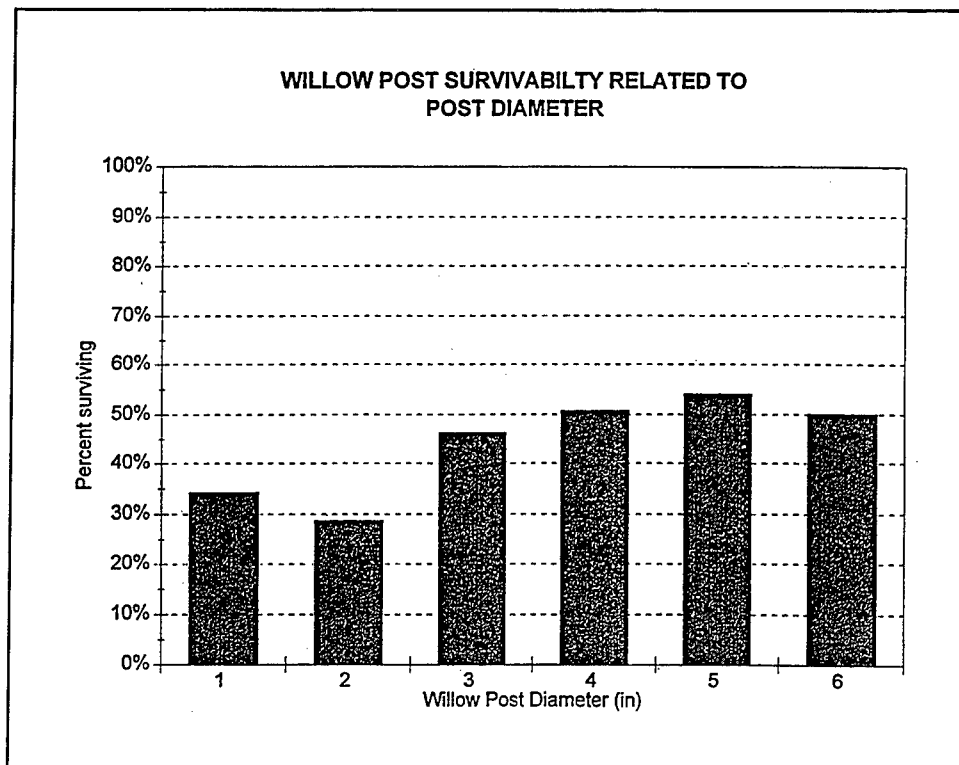
Figure 67. Willow post survivability related to post diameter

In 1994, the diameter of 293 dead and living willow posts was measured. The diameter of these posts ranged from 2 to 6.5 in. Each post was placed into a class based on diameter. The percent alive was then plotted versus the lower boundary of each class, as shown in Figure 67. The data indicate that the survivability increases as the diameter increases from 1 to 7 in.

Survival of the willow post is obviously necessary for long-term viability of the installation. The high mortality of willow posts can be attributed to insect infestation, lack of aerobic rooting conditions caused by impermeable soils, damage from high velocity, sediment-laden flood flows abrading the new growth, improper backfilling during construction, lack of sufficient moisture, and constant anaerobic rooting conditions due to standing water. The Harland Creek data suggest that the high mortality of the lower row of posts was the result of streamflow damage and the anaerobic conditions in standing water or poor soils. The high mortality of the upper rows, more than 6 ft above low water, may represent a site-specific threshold of sufficient moisture for sustaining growth.

Along with the recommended installation guidelines (Raphelt et al. 1995), the survivability of the willow posts at the Harland Creek site could have been improved by preventing erosion of the toe of the bank during the establishment period. Natural stone riprap placed at 1 ton per linear foot in a peaked longitudinal stone toe, continuous toe reinforcement using anchored cedar or willow trees, or use of manufactured products such as heavy fiber rolls placed along the toe, could be of benefit to system survivability. Interplanting of the willow posts with other species and the use of fascines buried along the rows would be of benefit in enhancing aggradation within the post system and could provide rooting medium in areas of poor soil conditions.

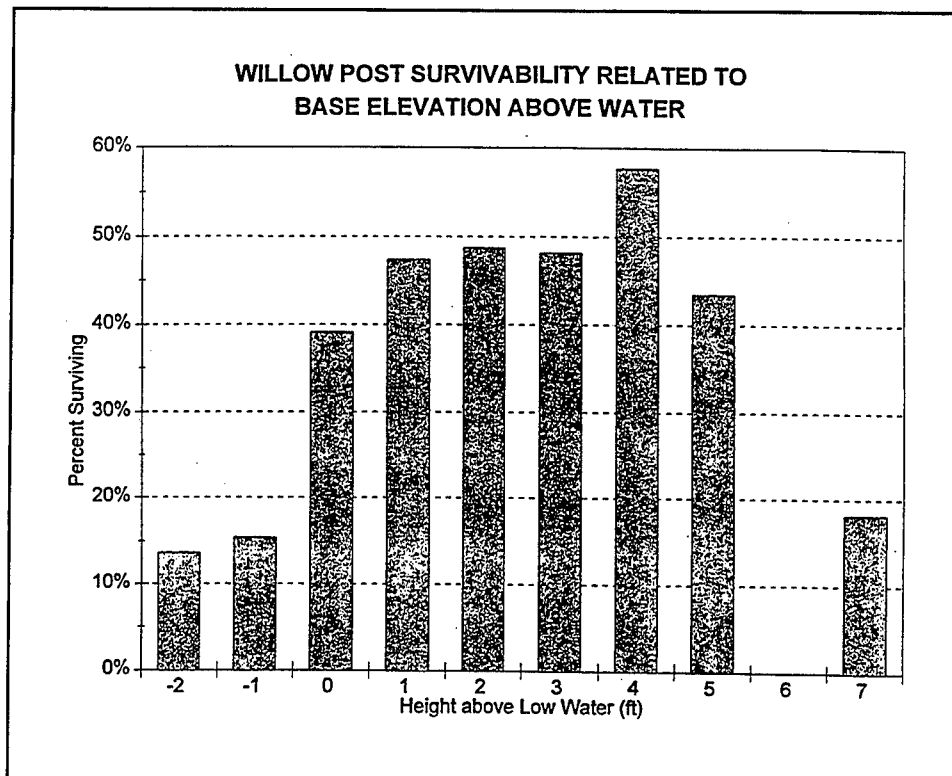
Figure 68. Willow post survivability as function of base elevation above low water

Similar to the diameter, the elevation at the base of the post above low water was measured for each of the 293 posts in the study reach. These elevations ranged from 2 ft below the water surface to 7.5 ft above the water surface level. The data were divided into classes of 1-ft increments, as shown in Figure 68. The data indicate that survivability reaches a minimum at the lower and upper ranges of the data. At several locations it was evident that scour of

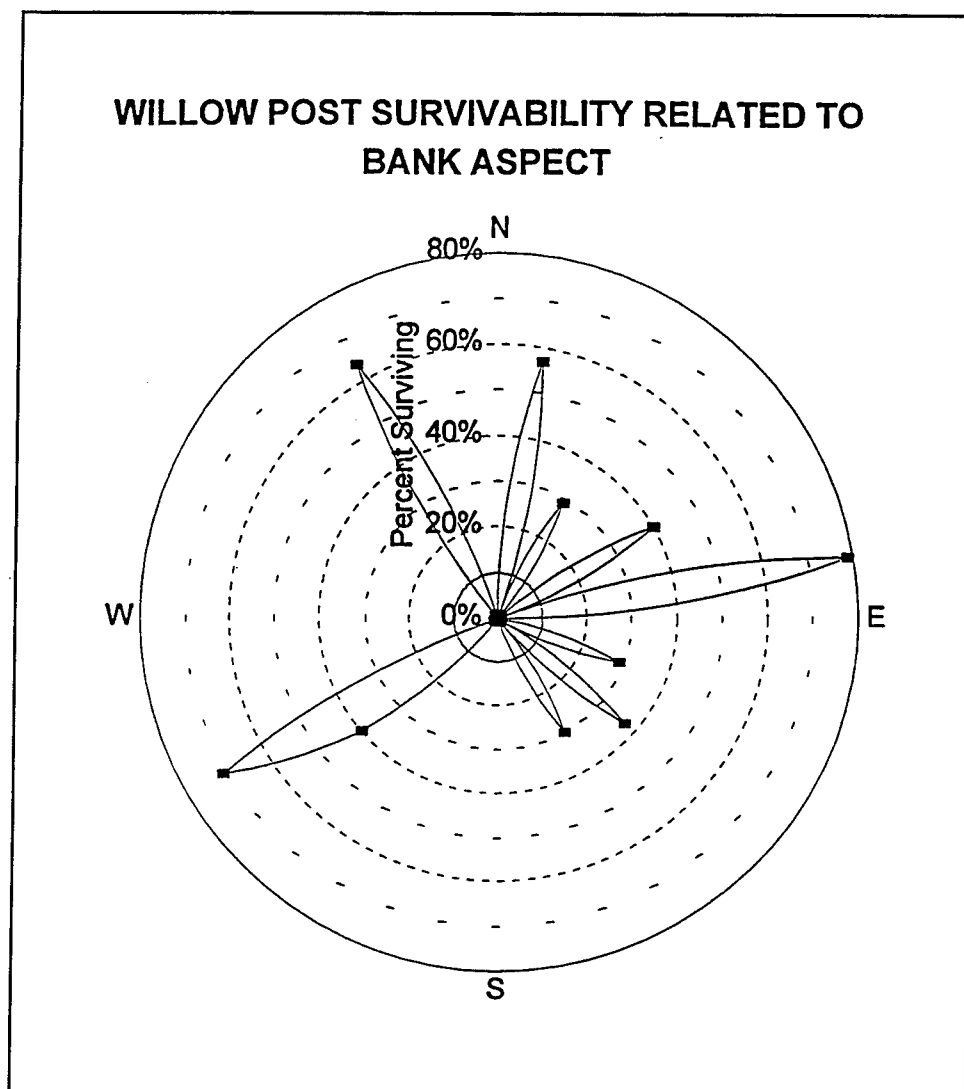
Figure 69. Willow post survivability as function of bank aspect

The aspect of the streambank, or the direction the bank faces, was measured using a Brunton compass. The aspect of the streambank data indicate that banks facing east or west have a greatest survival rate, and that banks facing north are better than banks facing south. Figure 69 portrays the aspect data.
